# Richmond Refinery LPS Bulletin – Reliability

## NHT Shutdown to Skim R-410 Catalyst

**Location:** D&R ABU, No.5  
Naphtha Hydrotreater (NHT)

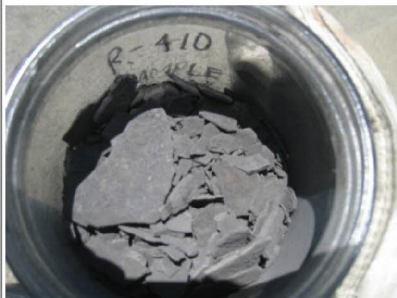
Particles collected May 2012.

Multiple foulants (mainly iron sulfide, but also sodium, coke, and diolefins) settled on top of the first R-410 catalyst bed, leading to the rapid dP increase in 2011 and 2012.

- 1) Install two six-inch layers of Catalyst Trap material to trap scale without increasing the dP.
- 2) Establish PMs for routine element replacements at V-420, and install a filter ahead of V-420 to remove scale upstream.
- 3) Determine a better process to flush wild naphtha and off-test GHT and FCC material than NHT.
- 4) While skimming the catalyst, remove excess scale from reactor walls.

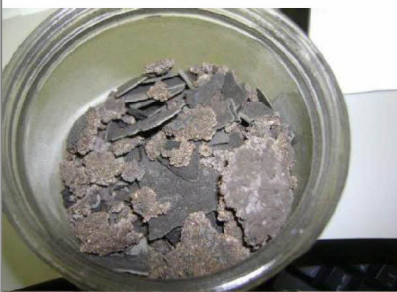
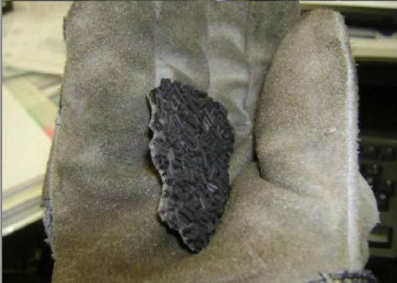
Particles collected February 2011.

R-410 was last skimmed in Feb 2011 resulting in a sub-optimal one-year catalyst run. Since the last skim, the dP started to gradually rebuild, but upon startup after the 4Q 2011 D&R major turnaround, the dP started to build more quickly than previously.
